CHAPTER IV: SIMPLE LAUNCHES

Natural and Existing Shorelines, Beaches, and Simple Ramps

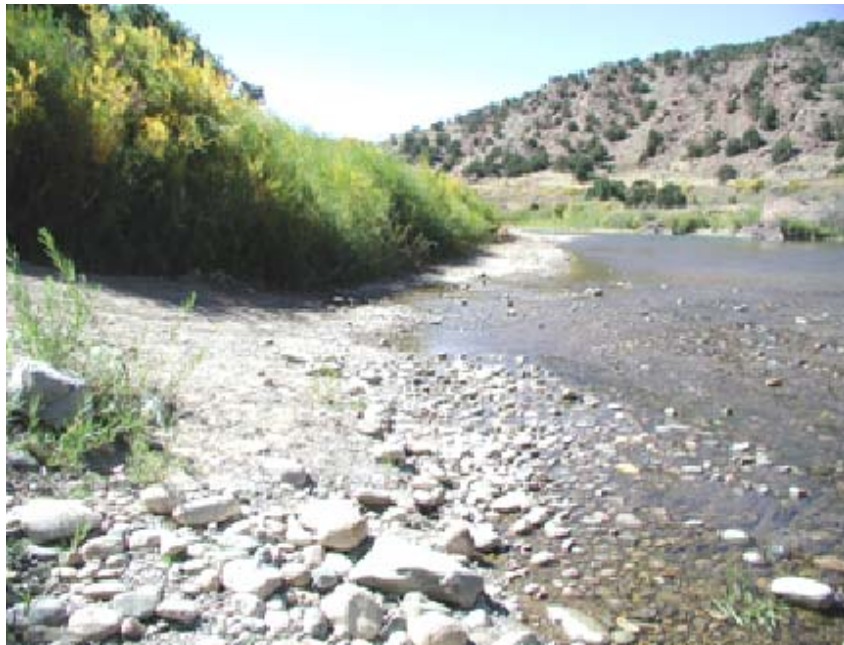
- 1) Rincon launch site, Arkansas River, Salida, Colorado

Photo 4A: Rocky beach provides river access

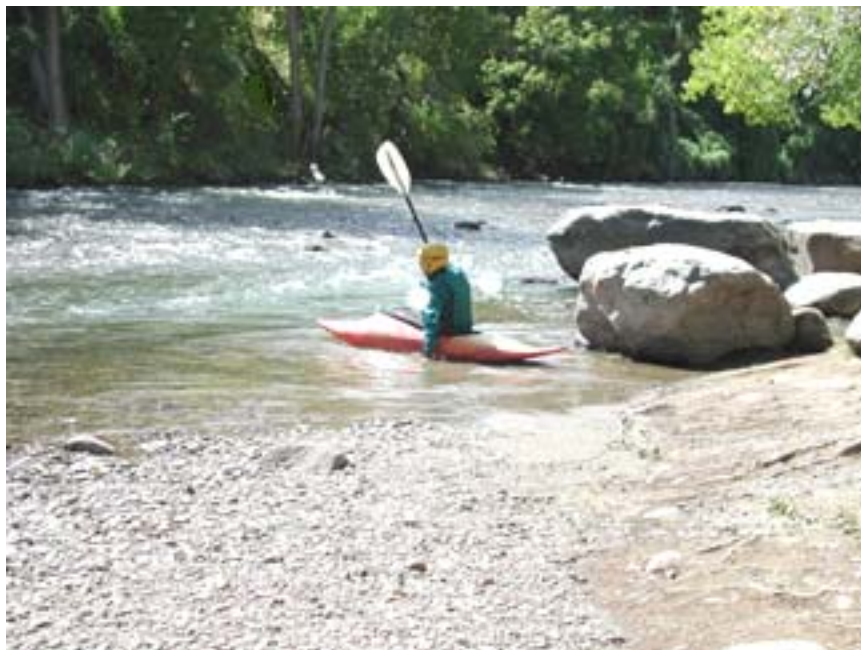
2) Clear Creek, Golden, Colorado

Photo 4B: Kayaker launches from a level bank

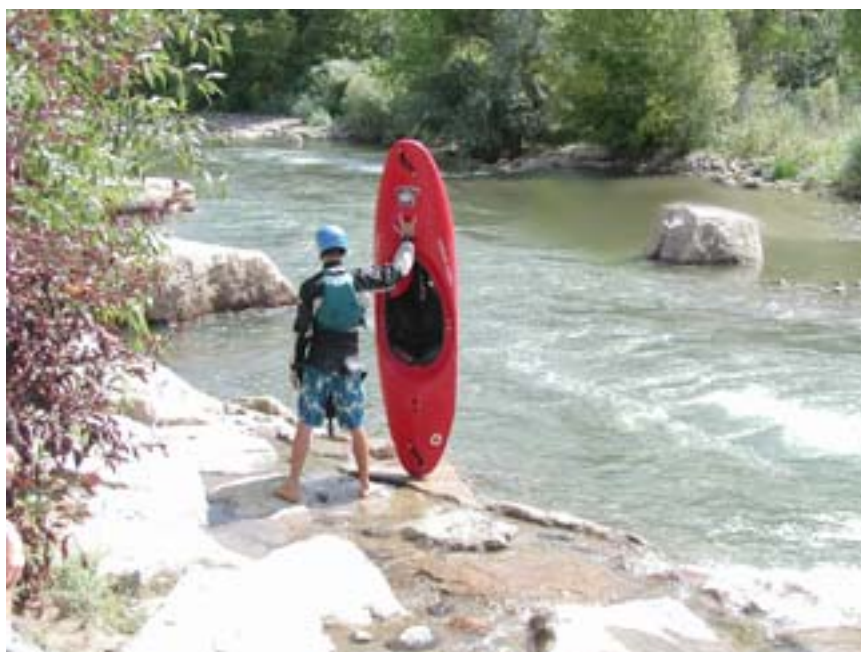
3) Clear Creek, Golden, Colorado

Photo 4C: Kayaker prepares to launch from flat rock outcrops

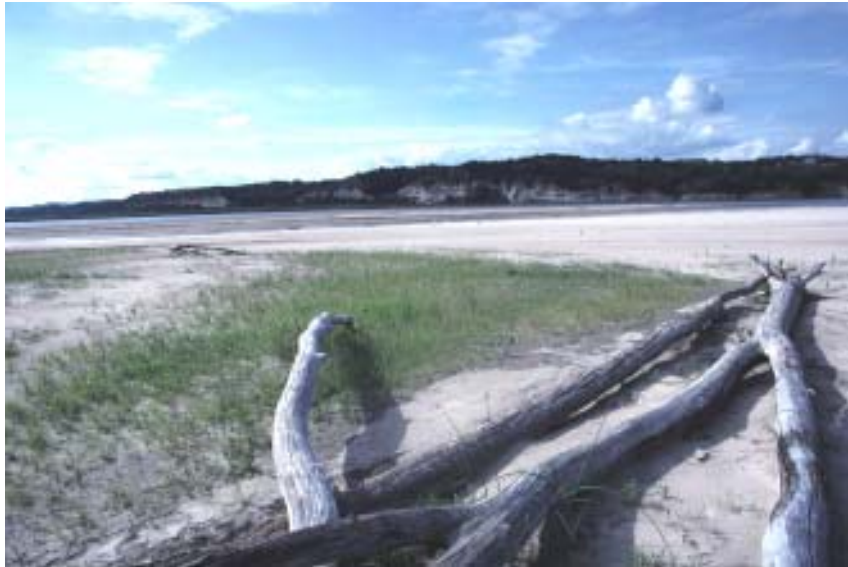
- 4) Missouri River, below confluence with Niobrara River, Nebraska

Photo 4D: Sandy beach provides access to the river

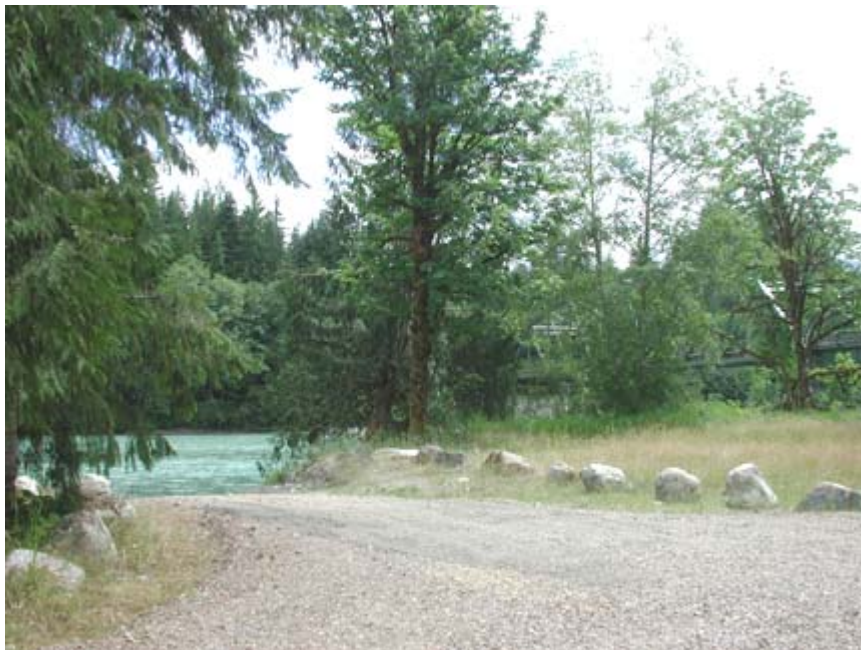
- 5) Sauk River, Washington

Photo 4E: River is accessible from a gravel road

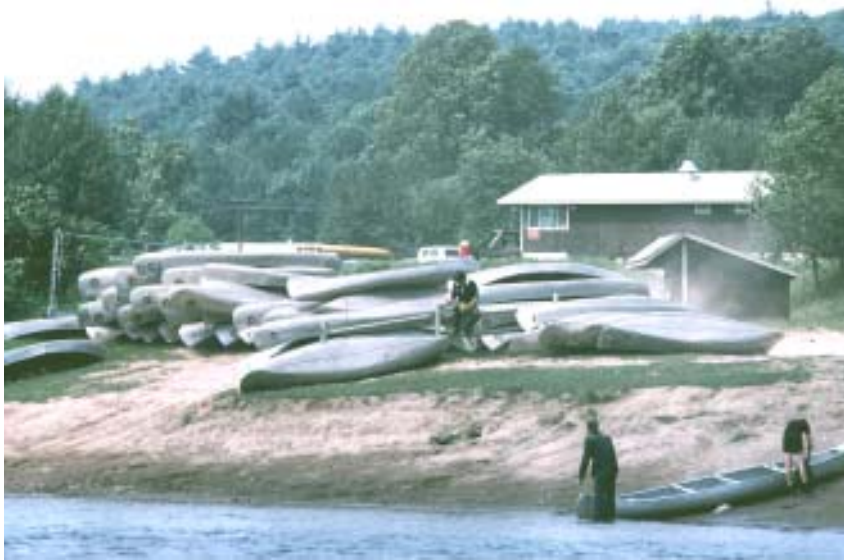
6) Delaware River, Narrowsburg, New York

Photo 4F: Canoes are easily launched from a sandy bank

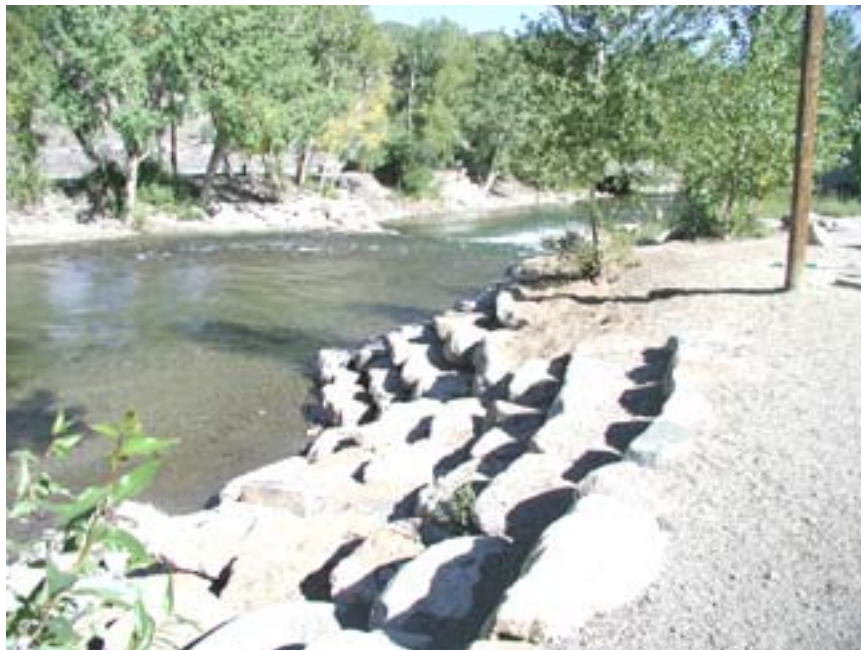
7) Restored river bank, Arkansas River, Salida, Colorado

Photo 4G: Restored bank with rock outcrops enables access at varying water levels
